US ARMY
LABORATORY COMMAND
MATERIALS TECHNOLOGY
LABORATORY

NONDESTRUCTIVE EVALUATION OF METAL MATRIX
COMPOSITES

S. W. SCHRAMM, G. M. KOLLER and J. W. ADAMS
IIT Research Institute
10 West 35th Street
Chicago, IL 60616

FINAL REPORT

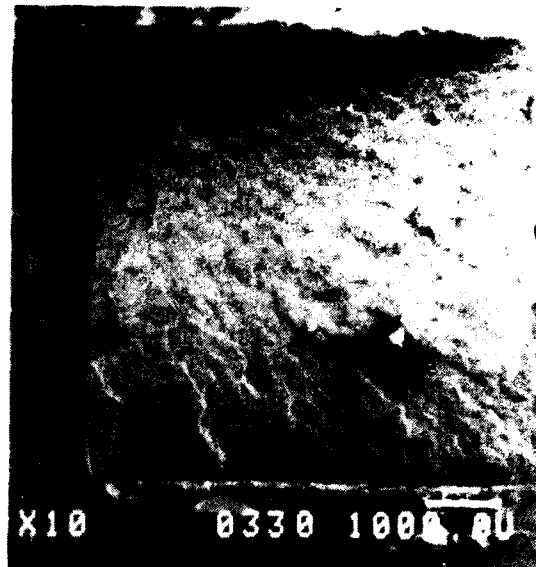
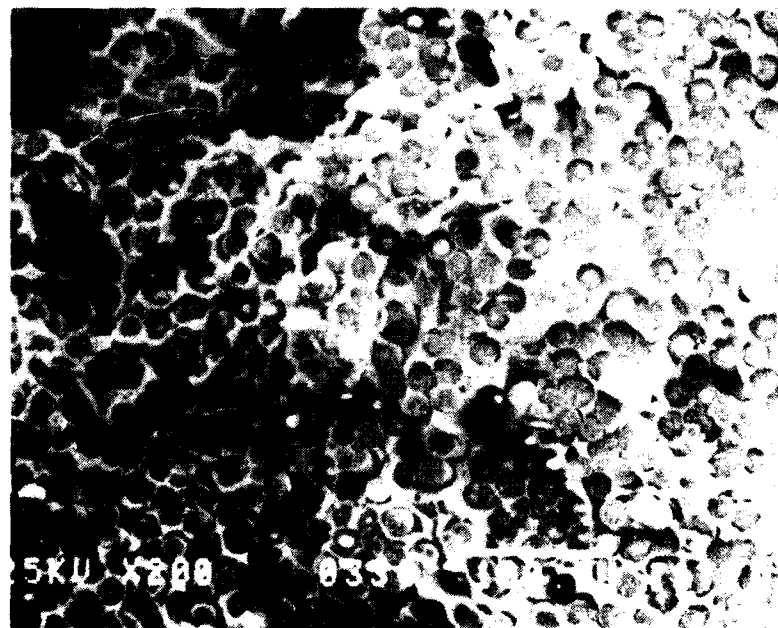
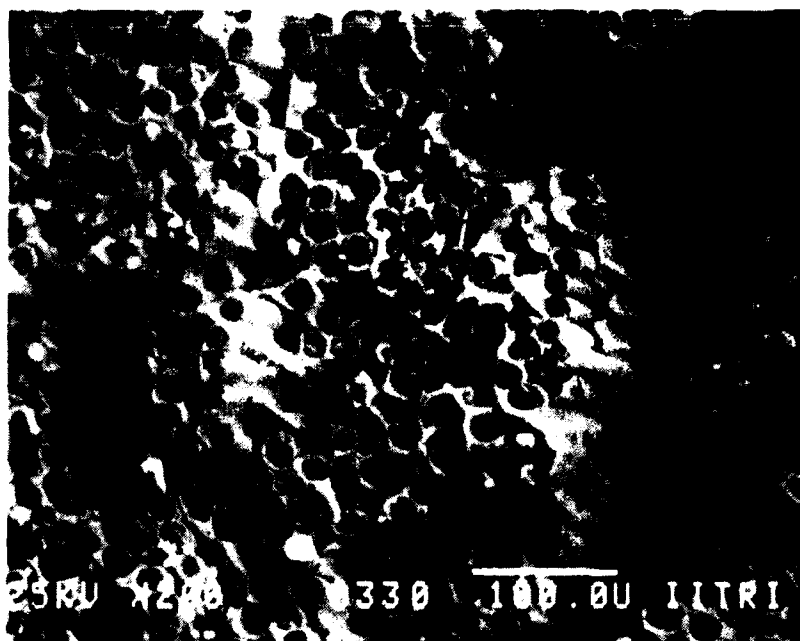
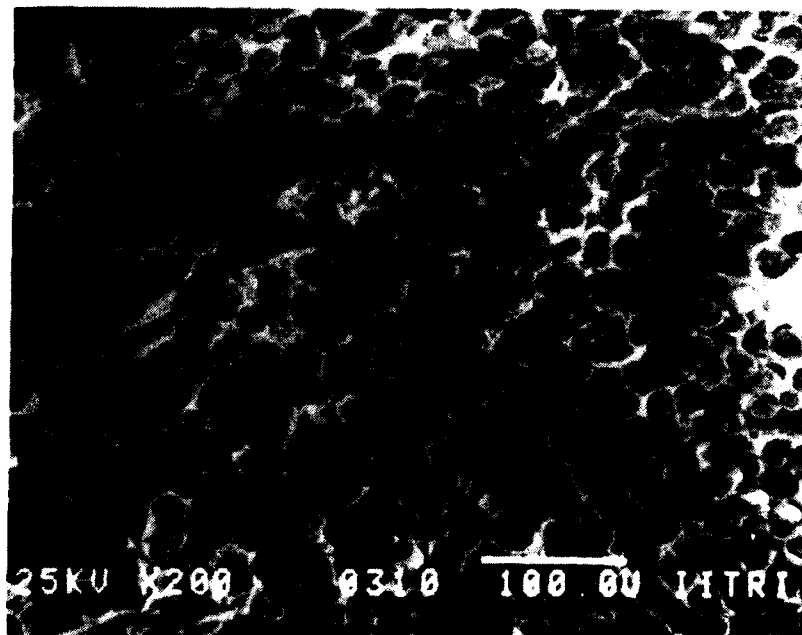
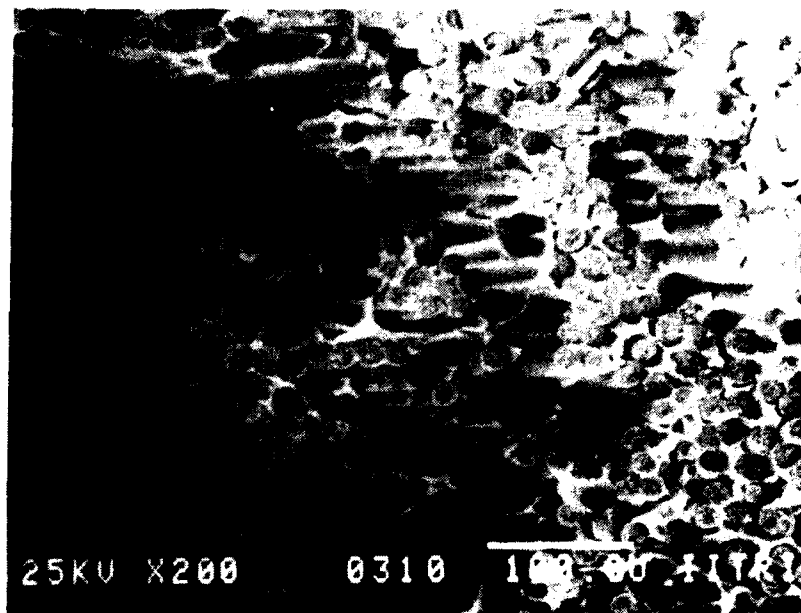
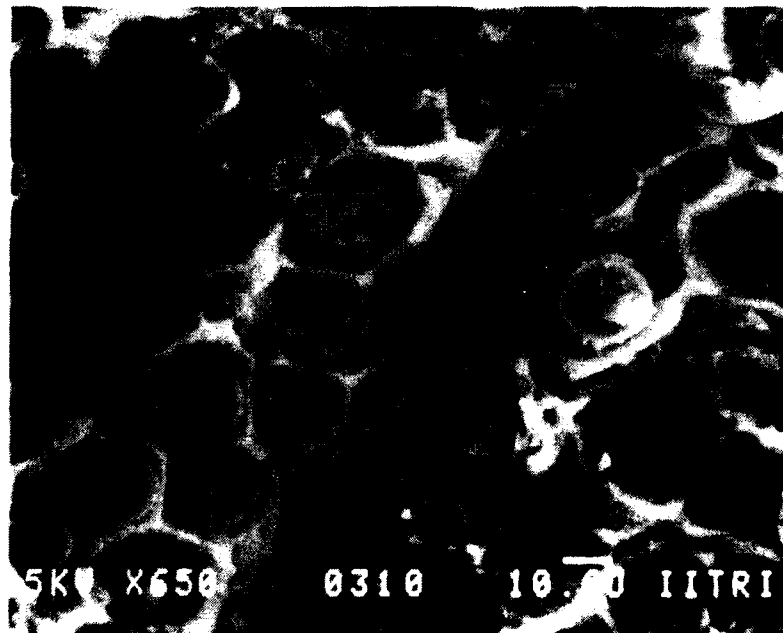
Figure 46. Representative fracture surfaces of type N3-3 and N3-1 ($+10^\circ$ and $+20^\circ$ off-axis fibers, respectively) material tested in uniaxial tension.

(a) SEM view of specimen N3-3-3 ($+10^\circ$ off-axis fibers): fracture origin is in the upper lefthand corner.

(b) View of specimen N3-3-3 in the 0° fiber portion of the fracture surface.

(c) View of specimen N3-3-3 in a 10° off-axis fiber region of the fracture surface.

(d) SEM view of specimen N3-1-1 ($+20^\circ$ off-axis fibers) fracture origin is in the upper righthand corner.

(e) View of origin area showing the aligned/off-axis fiber interface region (specimen N3-1-1).

(f) View of specimen N3-1-1 in the 0° fiber portion of the fracture surface.

(g) View of specimen N3-1-1 in a 20° off-axis region of the fracture surface.

(h) View of specimen N3-1-1 showing the brittle Al_2O_3 fiber fracture and the "cone" portion of the ductile Mg "cup and cone" fracture.

Two types of off-axis samples were prepared for tensile testing: $\pm 10^\circ$ and $\pm 20^\circ$. The three $\pm 10^\circ$ off-axis samples had rough fracture surfaces with some brittle fracture markings. Origins were within off-axis layers--one where the off-axis fibers intersected the corner of the sample, and two within off-axis bands of fibers which intersected the machined, non-gaged edges of the samples. Interestingly, the $\pm 20^\circ$ off-axis samples also had brittle-type fracture surface features. Origins were on the as-received, gaged surfaces of the samples very close to a corner and consisted of corrosion pits where Mg presumably had been removed during the ultrasonic evaluation due to the reaction of magnesium with water: $\text{Mg}_{(s)} + \text{H}_2\text{O}_{(l)} \rightarrow \text{MgO}_{(s)} + \text{H}_2(g)$. Figure 46 illustrates off-axis types of fracture surfaces.

The off-axis portions of the fracture surfaces indicate that the fibers failed in a brittle manner. There is little evidence of fiber pull-out. Figure 46h, photographed in the 0° portion of the fracture surface, indicates the ductile failure of the matrix.

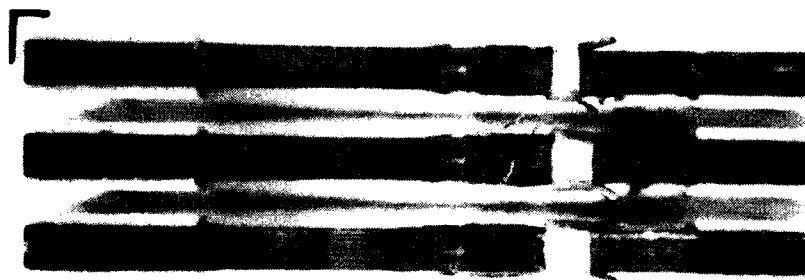
Figure 47. Fractures of type N4-3 (1/10 in. gap) material showing failure at the metal-rich region of each specimen.

(a) Side view of three 1/10 in. gap tensile samples showing fracture at the metal-rich region of the gage section.

(b) Magnified view of specimen N4-3-1 oriented as above.

(c) Fracture surface of specimen N4-3-3.

Three tensile samples were prepared from billet N4-3 so as to contain a 1/10 in. fiber gap region in the gage section. This flaw, as-fabricated, was somewhat larger and was the origin for each sample tested. An example is shown in Figure 47. A more discrete form of the same flaw type was fabricated into the N4-1 billet where a fiber fracture was simulated by one butted layer of cut Al_2O_3 fibers. The fracture surfaces of these samples were flatter than those of the 1/10 in. gap samples. Fracture origins were again at the discontinuity formed by the butted fiber layer for specimens N4-1-1 and N4-1-3. A slight Mg-rich region may be seen on the typical fracture surface shown in Figure 48. The region indicates the location of the cut and butted fiber layer. Specimen N4-1-2 fractured at one end of the gage section, not at the centrally located abutment. The fracture surface features were similar to those seen on unflawed tensile specimens, with the fracture origin not identified.

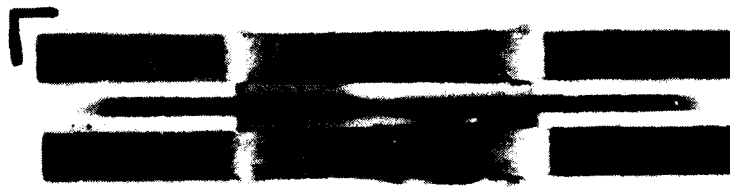
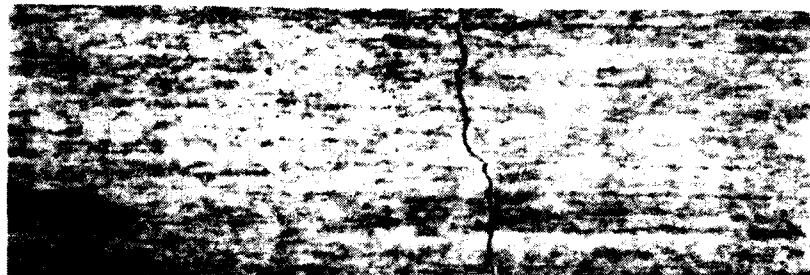
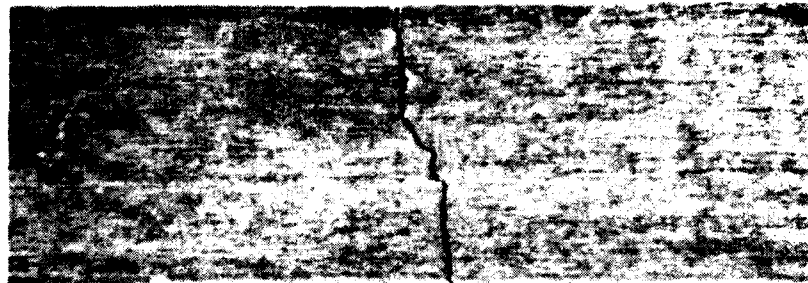
Figure 48. Fractures of type N4-1 (butted fibers) material showing failure at the flaw centrally located in the gage section.

(a) Side view of butted fiber tensile specimens showing fracture at the centrally located flaw.

(b) Magnified view of specimens oriented as above.

(c) Fracture surface of specimen N4-1-1.

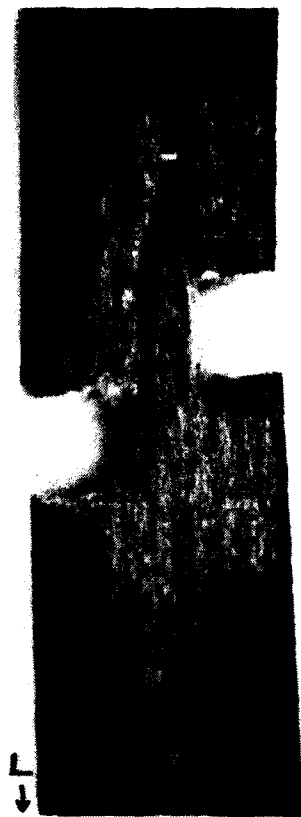
Figure 49. Fracture surfaces of type N5 (fiber/matrix debonding) material showing failure at the delaminated region of the specimen.

(a) Schematic showing specimen removal location superimposed on coupon analog C-scan.

(c) Magnified view of the delamination of specimen N5-1-1. 5.5X

(b) Top and side views of tested specimens showing failure in the delamination region. ~1X

Samples having a region of fiber/matrix debonding within the gage section of a tensile coupon exhibited the most surface irregularity and no evidence of brittle failure. The delaminated region was the fracture origin in each sample tested, as seen in Figure 49.

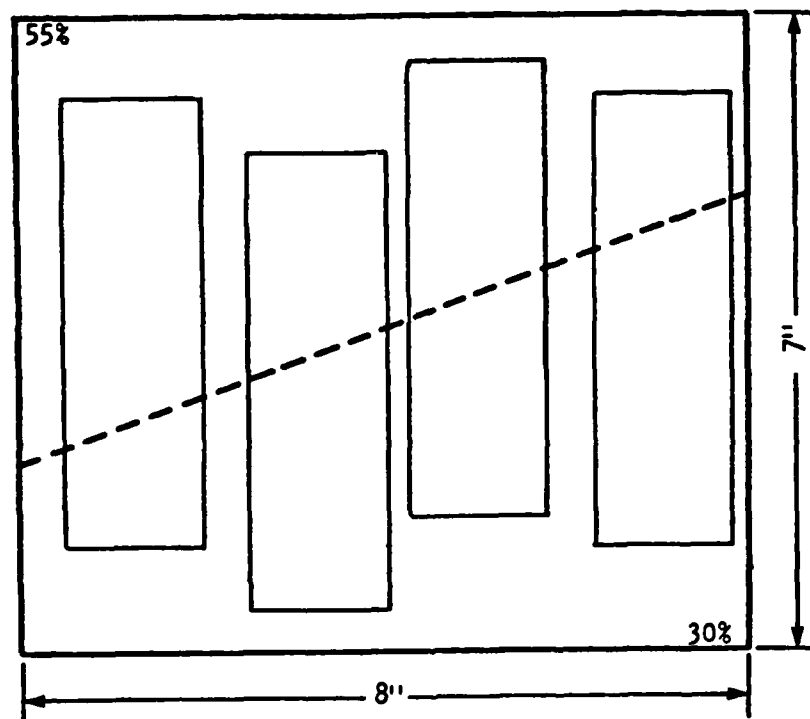
Figure A6. Schematic of FP/Mg casting plate with nonuniform volume fraction. Possible locations of final coupons are shown.

- Nonuniform Volume Fraction, Figure A6 (N2 Type)

Nonuniform volume fraction was produced by dividing the casting plate diagonally into two zones. One zone consisted of a volume fraction of 30% and the other zone a volume fraction of 55%. The final coupons were removed from the casting plate in such a way that a part of each zone was to be represented in each final coupon.

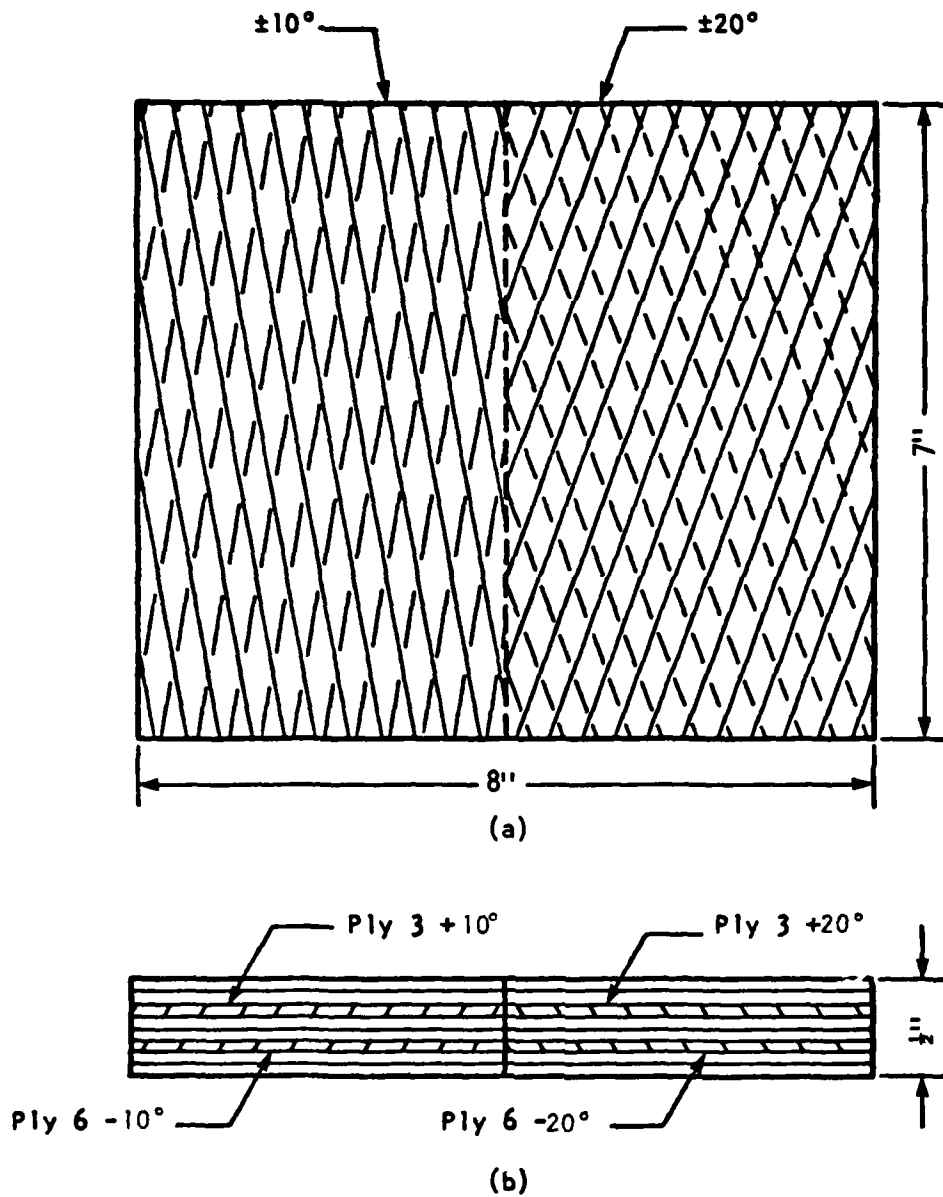
Figure A7. Schematic of FP/Mg casting plate with fiber misalignment. (a) Separation of casting plate; (b) location of off-axis fibers through the thickness.

- Fiber Misalignment, Figure A7 (N3 Type)

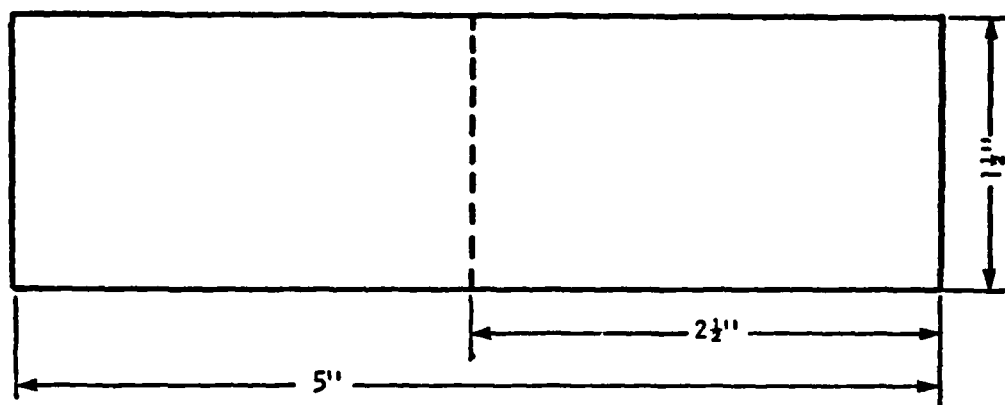
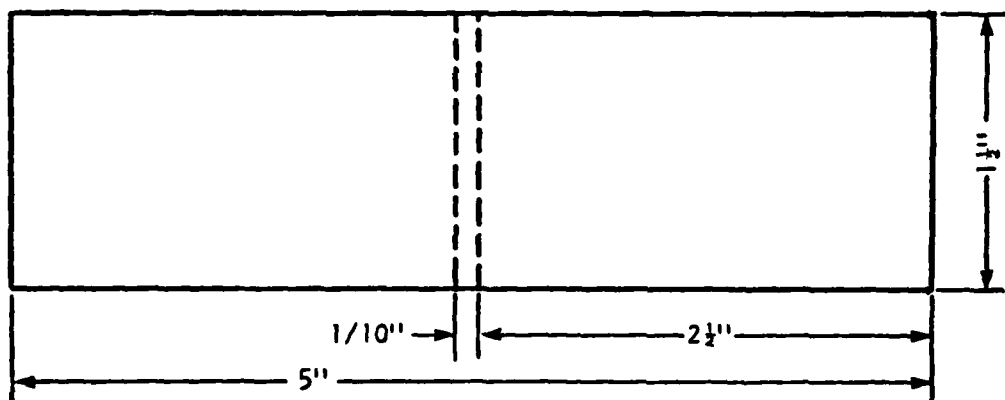
Figure A8. Schematic of FP/Mg coupons with fiber fracture of the fourth ply. (a) Fractured fiber ply butted together. (b) Fractured fiber ply separated by 1/10 in.

- Fiber Fracture, Figure A8 (N4 Type)

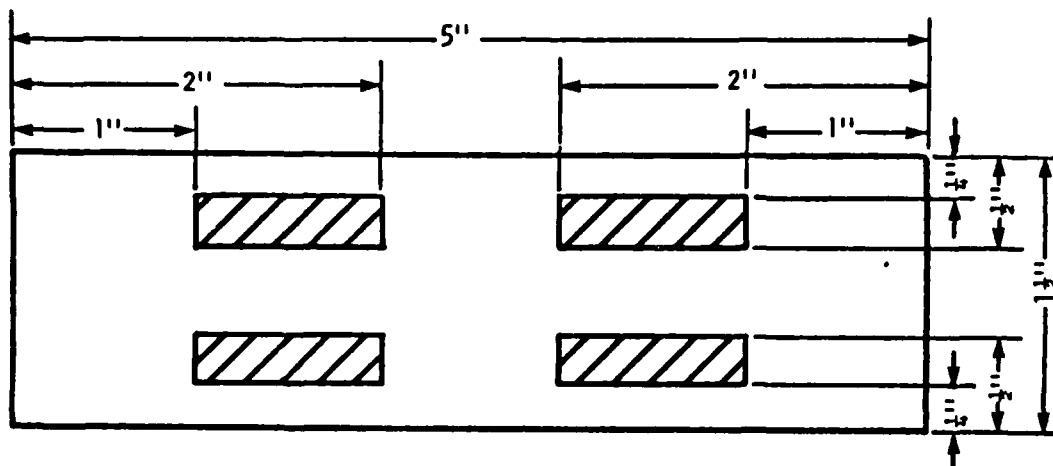
▨ Area of Fiber/Matrix Debonding

Figure A9. Schematic of FP/Mg coupon with areas of fiber/matrix debonding of the fourth ply.

On each coupon, four 1/4 in. wide x 1 in. long x 1 ply thick areas of fiber/matrix debonding was produced by burning out the fiber binder with a torch using the IITRI supplied ceramic "template." A boron nitride slurry was applied to the "burned out" areas to inhibit fiber/matrix bonding. The single ply with the "burned out" area was located at the mid-thickness of the coupon, i.e., the fourth or fifth ply of a nominally 8-ply specimen.

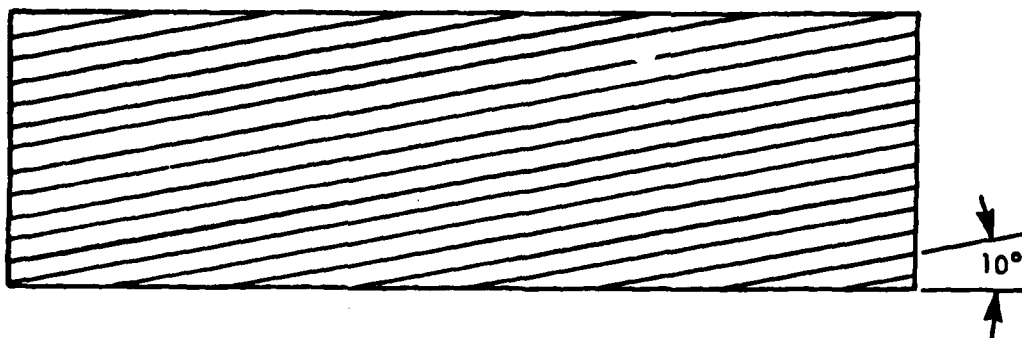
Figure A10. Fiber orientation of fourth and fifth layers of Type O4 FP/Mg specimens.

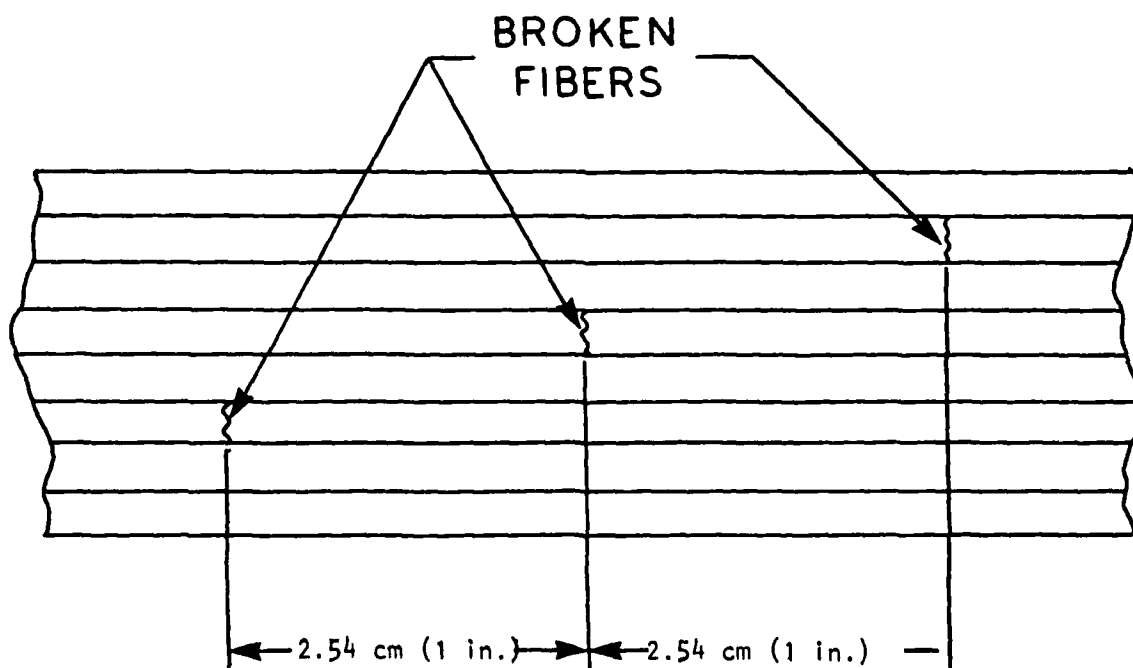
Figure A11. Fiber fracture of second, fourth, and sixth layers of Type O5 FP/Mg specimens.

- Type 05: Fiber Fracture, Figure A11. Fiber fracture was generated by cutting the second, fourth, and sixth fiber plies at staggered positions along the length of the specimen. When the fiber plies were stacked, the cut plies were separated by approximately 0.32 cm (0.13 in.) providing a migration path for the matrix material.

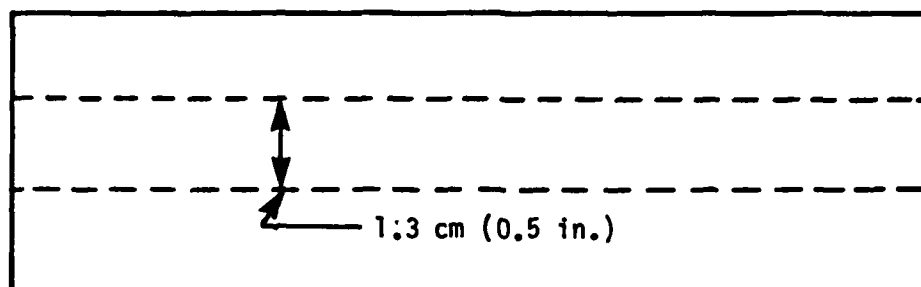
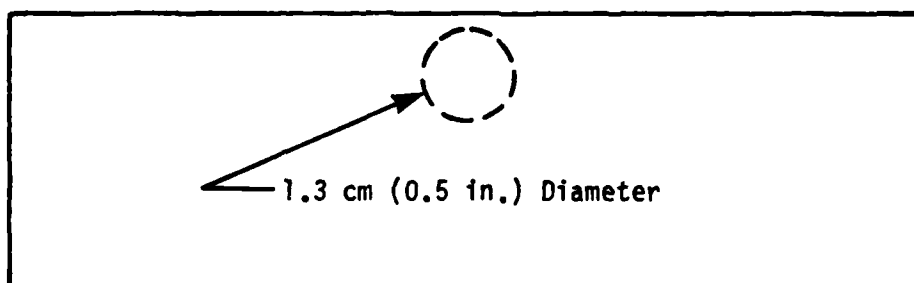
Figure A12. Areas where fibers were removed in fourth layer
Type O6 FP/Mg specimens: (a) specimens O6-1 and O6-3,
(b) specimen O6-2.

- Type 06: Nonuniform Fiber Distribution, Figure A12. In two of the specimens, nonuniform fiber distribution was created by removing a 1.3 cm (0.5 in.) wide strip of fibers from the fourth and fifth plies of the laminate parallel to the longitudinal axis of the specimen. In the third specimen, a 1.3 cm (0.5 in.) diameter hole was cut in the fourth fiber ply near the center of the specimen.
